ST-engineering

More value for your energy

Who we are

ST Engineering is able to perform the following instrumental checks on photovoltaic installation:

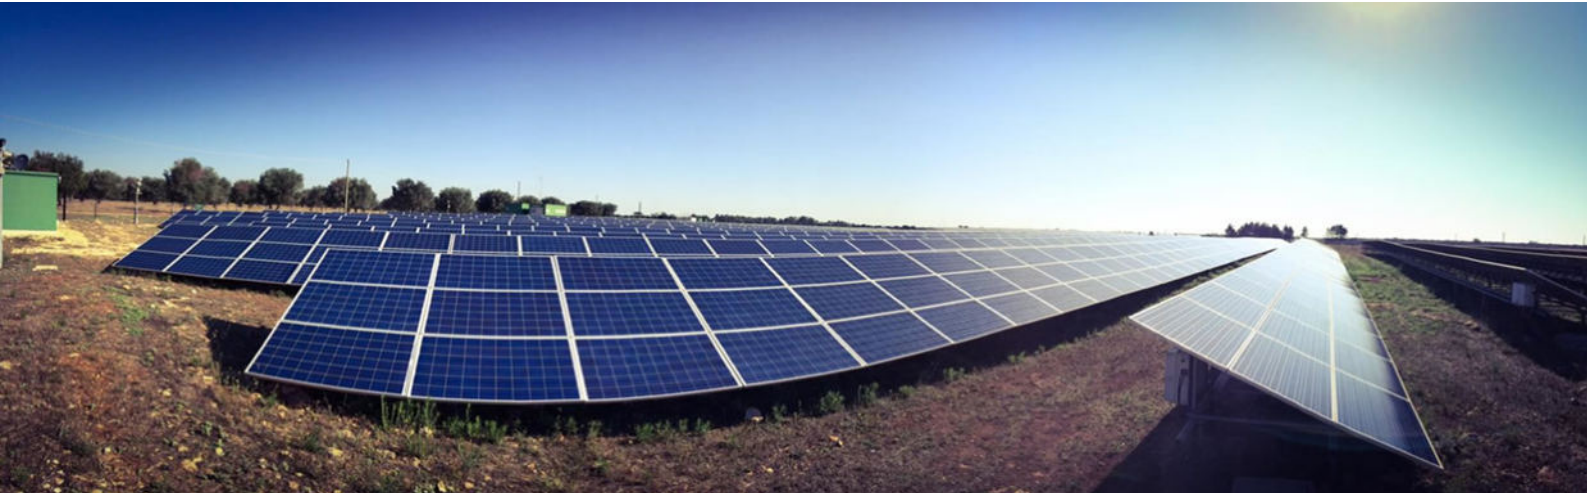
THERMOGRAPHY ON PV FIELDS WITH DEFECTS AND HOT-SPOT DETECTION

We perform thermographic analysis on your photovoltaic modules, electrical panels, string and centralized inverter in order to find some operating faults or thermal anomalies. We detect the presence of hot-spots on the modules. The cell affected by hot-spot is systematic subjected to a premature aging in the case in which the phenomenon is characterized by a dissipation of energy in the cell lower than the maximum dissipated by the same. The breaking of the same in the opposite case. Due to the strong stress at the local level, the area may also become hot and the cell fuse. In this case, the interruption of the electricity production is unavoidable and in the worst case, the module can catch fire.

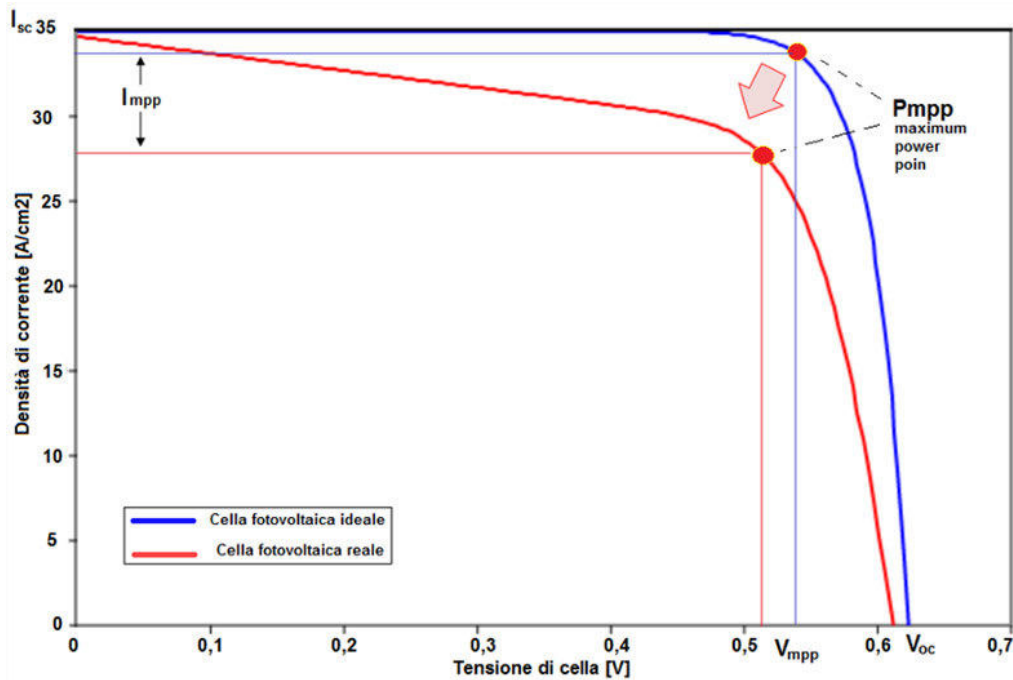
ANALYSIS OF PHOTOVOLTAIC MODULES EFFICIENCY AND I-V CURVE TRACER

The I-V curve tracer provides information about the performance decrease, that the module may have suffered over time compared to the characteristics declared by the manufacturer in the technical sheet.

Pmax	Voc	Vmpp	Impp	Isc	Irraggiamento	Temp. Modulo	FF	Temp	alfa	beta	tol+	tol-
Misura 176	Ok* (-0,28%)												
176 Misura@OPC	192,86	33,71	25,57	7,54	8,23	929	45,0	70	MANU	0,0307	-0,325	3	3
176 Mis Avg@OPC	192,86	33,71	25,57	7,54	8,23	929	45,0	70	MANU	0,0307	-0,325	3	3
176 STC	224,38	36,14	27,64	8,12	8,80	1000	25,0	71	MANU	0,0307	-0,325	3	3
176 Nominale	225,00	37,91	29,28	7,69	8,36	1000	25,0	71	MANU	0,0307	-0,325	3	3

According to the main structural parameters of the photovoltaic modules (such as I_{mpp}, V_{oc}, V_{mpp}, I_{sc} and the losses as a function of temperature of the form), declared in the technical sheet by the manufacturer, it is possible to perform a comparison between the measurements taken and the start module characteristics. The I-V curve test is executable both on the individual modules and on a string of modules which together constitute what is commonly called the "photovoltaic generator", an integral part of a Single-Phase or Three-Phase photovoltaic installation.

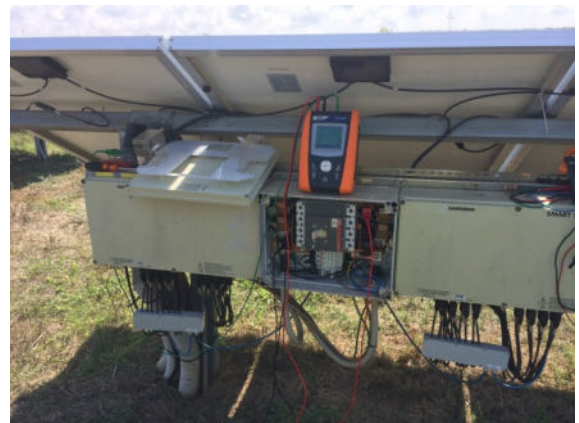
PV MODULES AND STRINGS INSULATION RESISTANCE MEASUREMENT

Each photovoltaic system has both before the network connection that the process of placing a different potential than the earth. Only an adequate insulation with respect to earth prevents the current coming from the photovoltaic system to spill into the ground, excluding the danger in case of contact and further losses. The total leakage current of the earth, also called leakage current, is the sum of the dispersion value of the individual components in the installation: photovoltaic Modules, DC cables, Inverter.

We carry out the measurement of all the insulation components of the photovoltaic installation. It is easy to imagine how a good insulation resistance of the photovoltaic modules (the norm CEI 64-8 sets a minimum insulation value at 1MΩ with test voltages of 500V or 1000V DC) and a poor insulation of the DC wires in the stretch of photovoltaic modules-inverter, leads to a malfunction of the same, with consequent loss of the energy production.

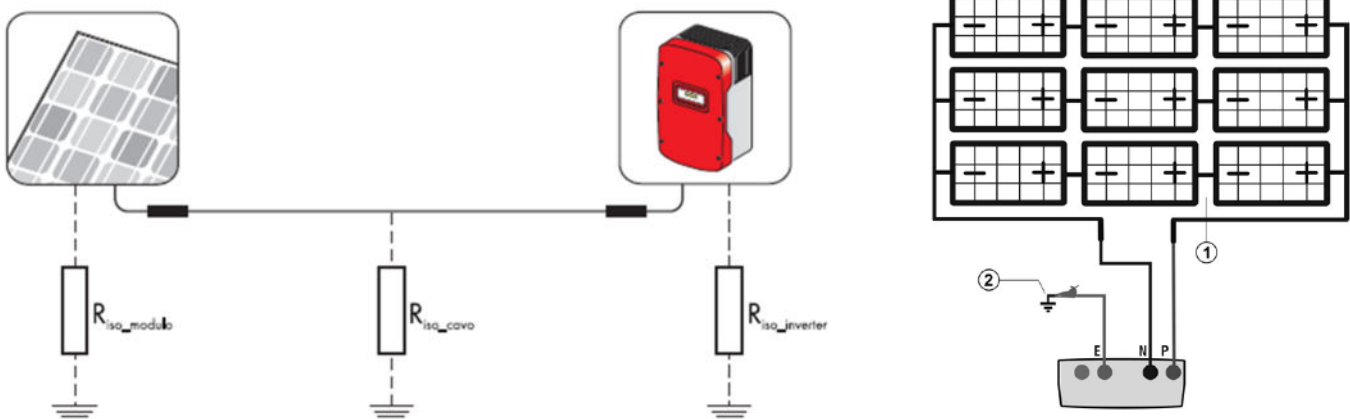
N°	Misure	Esito:	Descrizione
58	Inverter020\58 MΩ Stringa 16/05/2015	Ok	18 MODULO SINGOLO
	MΩ Stringa		
	Ri	>200 MΩ	Ok
	VEP	0 V	
	VPN	34 V	
	Vmis (+)	1.058 V	
	V0 nom	1.000,0 V	
	R Lim	1,0 MΩ

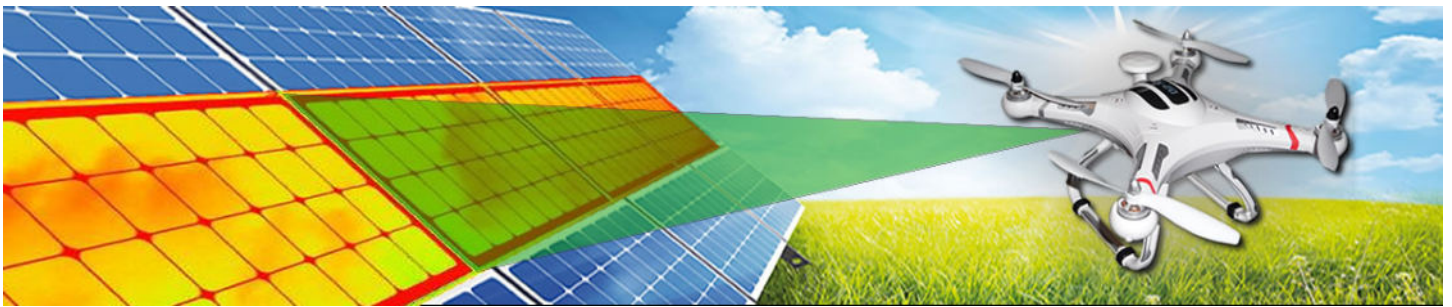
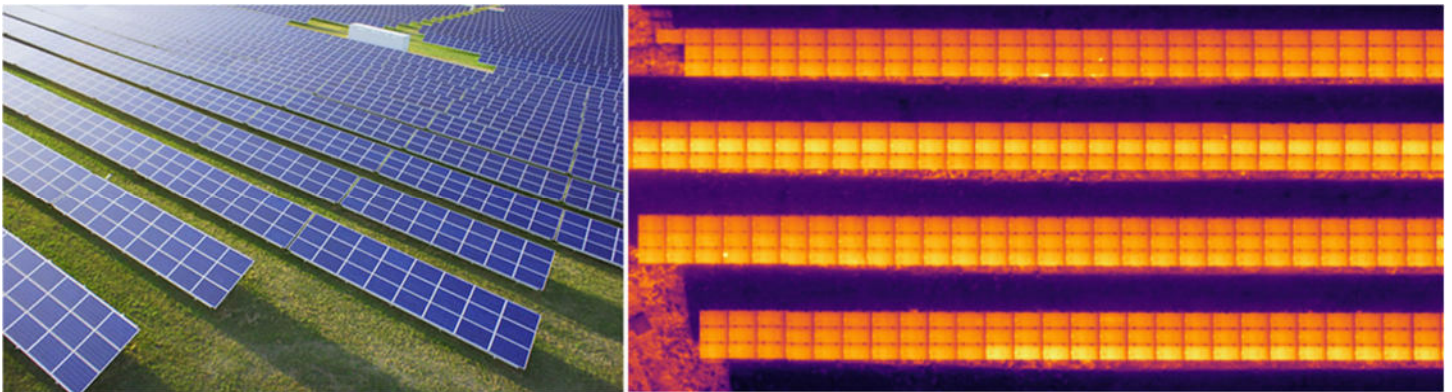
THERMAL IR ANALYSIS WITH DRONE FOR ANY PHOTOVOLTAIC INSTALLATION SIZE

ST Engineering is able to offer aerial and high resolution thermal imaging analysis for easy identification of photovoltaic modules hot-spot or cells breakage for the same module.

Analysis with infrared camera is assuming greater importance in the field of technical verifications on photovoltaic installation. But what is possible to detect by this analysis on the photovoltaic modules? When a cell does not work or does not generate energy because it is not receiving solar radiation, it could be polarized inversely. So it will work like a charger instead of a generator and this could lead in a high heat dissipation. This situation is easily detectable with an infrared thermo-camera and takes the name of "Hot Spot".

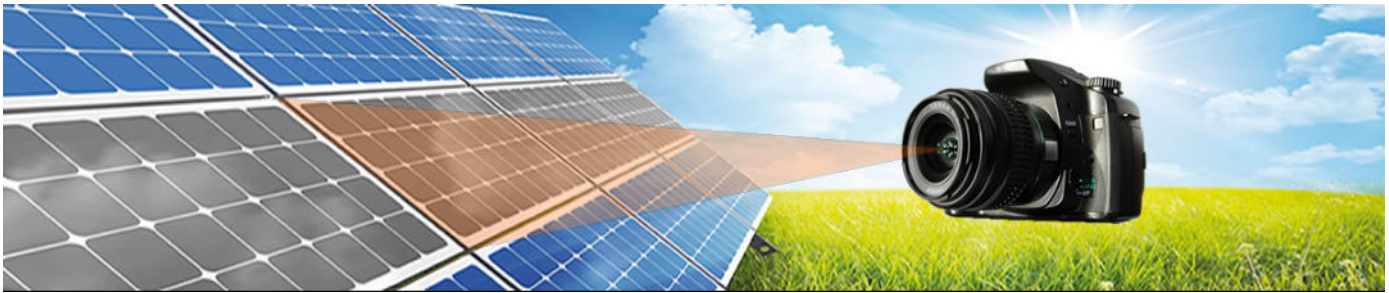
This test is based on the photovoltaic inverse process. An inverse voltage is applied to verify the current flows while a special IR sensor camera makes visible the infrared light emitted by the cells. The working cells will have a bright appearance, while the damaged ones will appear dark. We can detect, with electroluminescence test, the faulty bypass diodes problem (short circuit), micro-cracks in the solar cells, PID effects (Potential Induced Degradation) and ribbon contact defects (face to face cells contact).

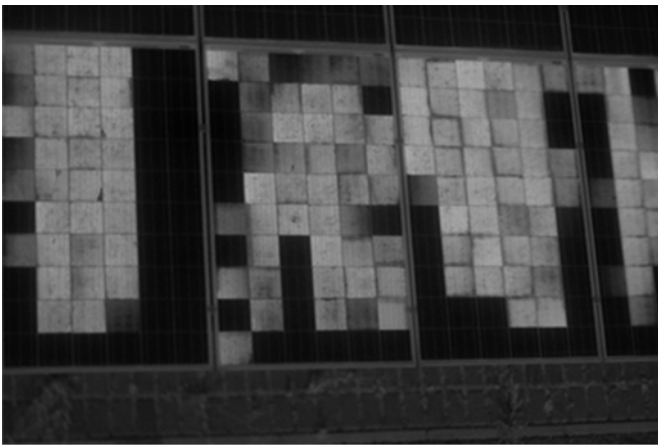
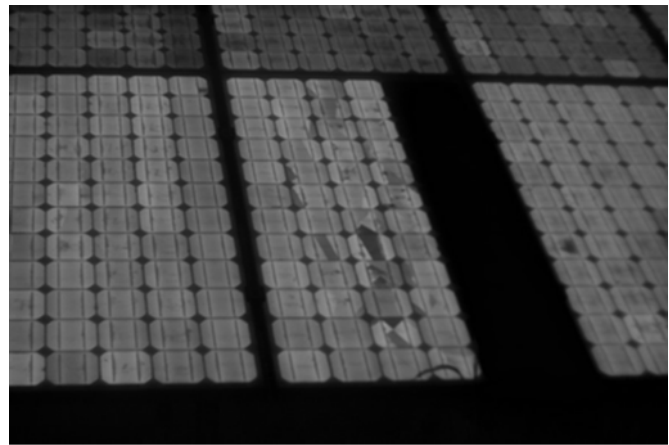
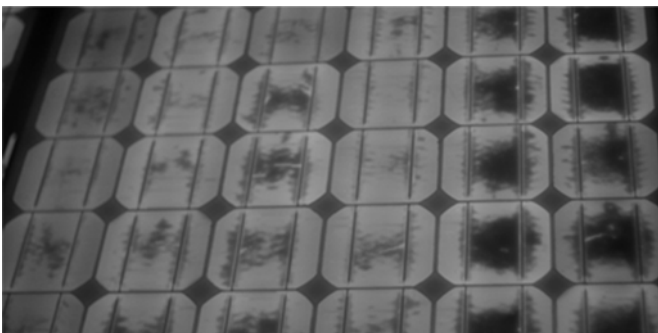
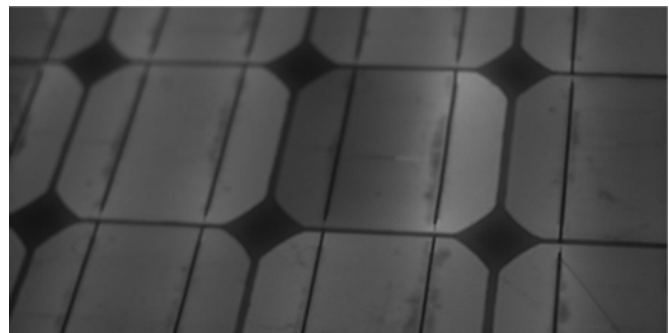
ELECTROLUMINESCENCE ANALYSIS (P.I.D., CELL CRACKS, DIODES)

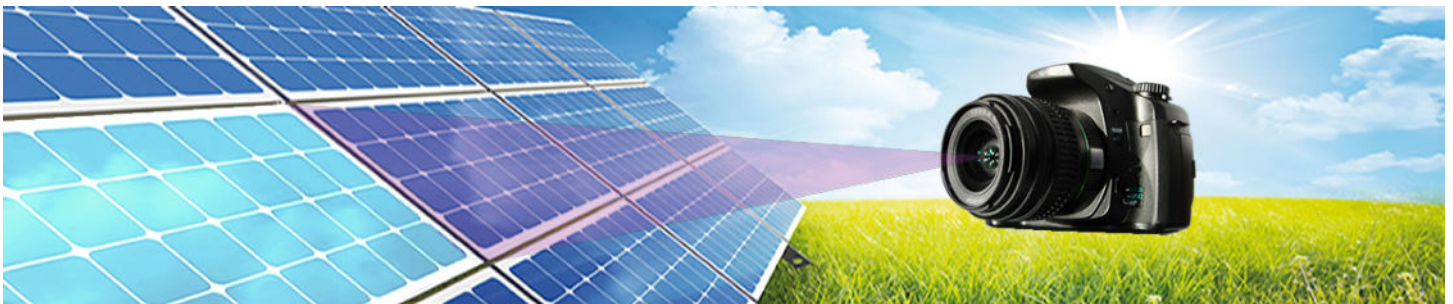
An innovative technique used for the study of defects in photovoltaic modules is the Fluorescence test (FL). This method exploits the homonymous phenomenon of fluorescence which occurs thanks to the presence of some atoms present in the module's EVA. This technique can be used as a complementary technique of the electroluminescence for the identification of defects in module cells. The fluorescence technique is very often used for the assessment of damage from atmospheric agents on photovoltaic modules (eg Hailstorm). The following image shows an example of a photovoltaic module with cell crack due to impact from hailstorm.

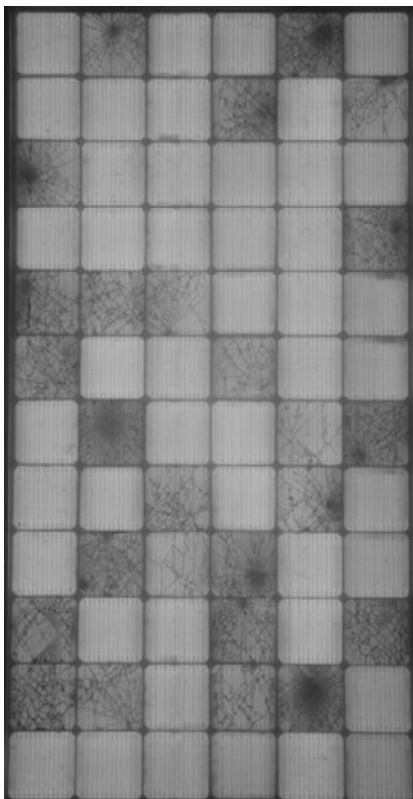
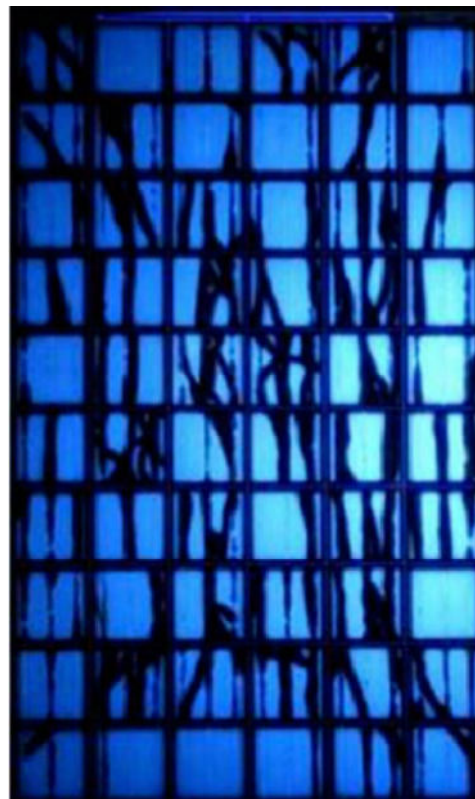
FLUORESCENCE ANALYSIS (CELL CRACKS, EVA DEGRADATION AND OTHER)

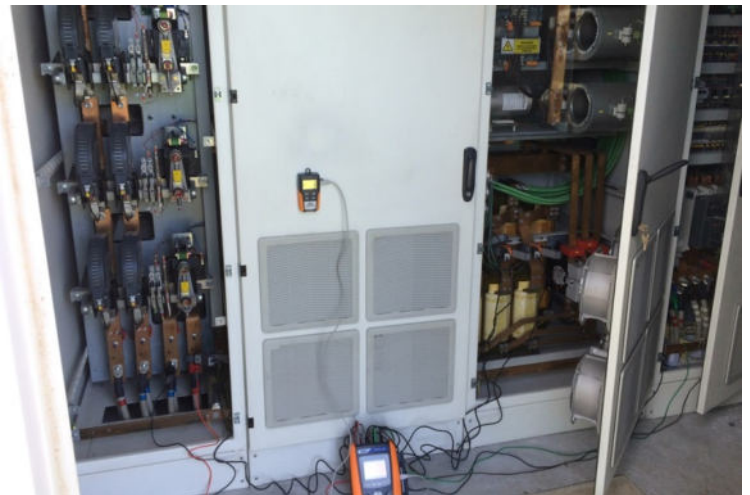
CENTRALIZED INVERTERS PERFORMANCE RATIO MEASUREMENT (PR%)

The Performance Ratio (PR%) is expressed in percentage and defines the relationship arising from the actual and the theoretical yield of the inverter (or PV installation). It indicates the percentage of energy really available once deducted the losses of energy. The PR can be measured both for central inverters and photovoltaic generator (modules).

FOTOVOLTAICO - ESITO:SI	
PRp = 0.837	Pac = 181.9 kW
Pdc = 188.4 kW	pf = 1.00 i
η_{dc} = 0.87	η_{ac} = 0.97
Vdc = 478.3 V	Vac1 = 255.5 V
Idc = 393.9 A	Iac1 = 411.4 A
Irr = 898 W/m ²	Vac2 = 254.8 V
Pnom = 241.8 kW	Iac2 = 407.3 A
Tc = 29.0 °C	Vac3 = 255.1 V
Te = 15.0 °C	Iac3 = 412.4 A

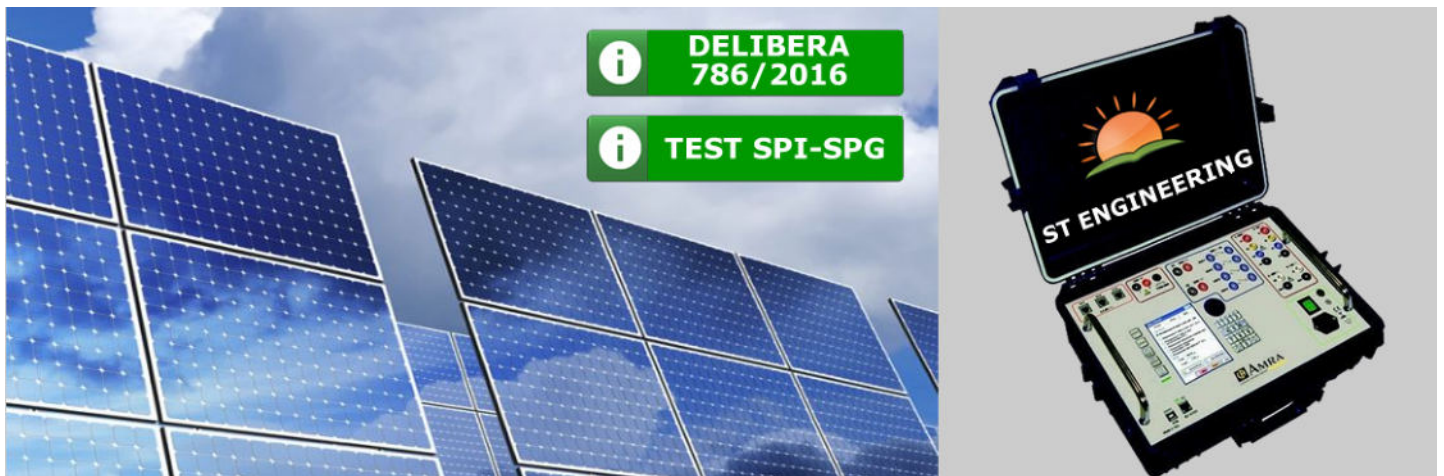
TECHNICAL DUE DILIGENCE FOR ANY PHOTOVOLTAIC INSTALLATION

We carries out the complete Due Diligence of a photovoltaic plant in one working day (for 1 MWp plant), providing to our customers a complete and reliable technical status report. Our engineers perform the measurements in the field (according to specific techniques required by the customer) with calibrated and certified equipment of the latest generation.

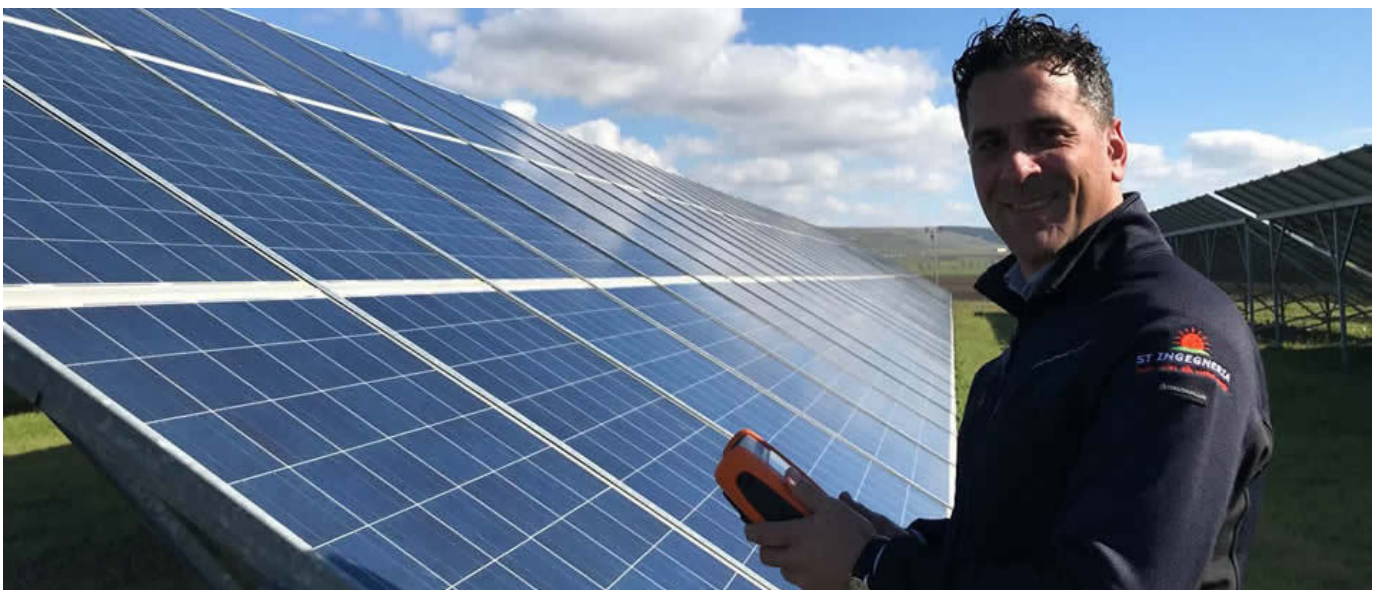
GEO-REFERENCED MODULES SERIAL NUMBERS SURVEY AND AUTOCAD LAYOUT RECONSTRUCTION WITH DRONE

We carry out the survey of the serial numbers of photovoltaic modules on large photovoltaic systems of any power, with reconstruction of the Autocad system layout by drone with centimeter precision.

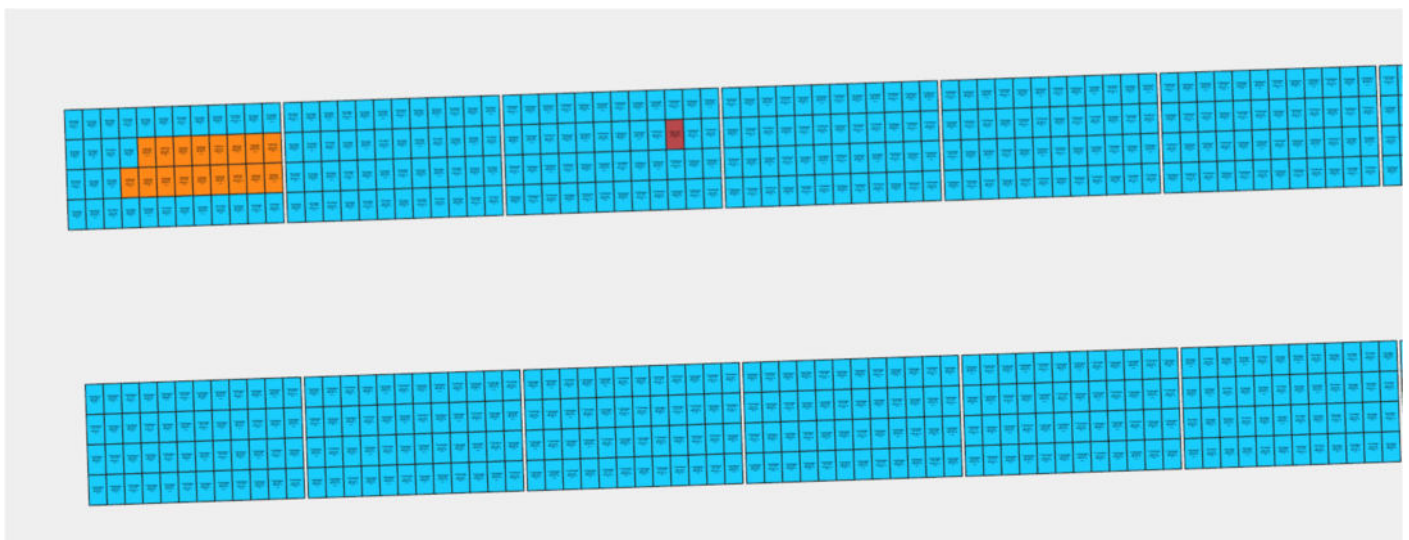
Possibility of scanning the serial numbers of the modules with front / back label, Bar-code / Qr-code and survey of the alphanumeric serial numbers even in the absence of a bar / qr code, with video-photographic recognition and direct OCR conversion. Digital publication of the results on the PV-SCAN portal.

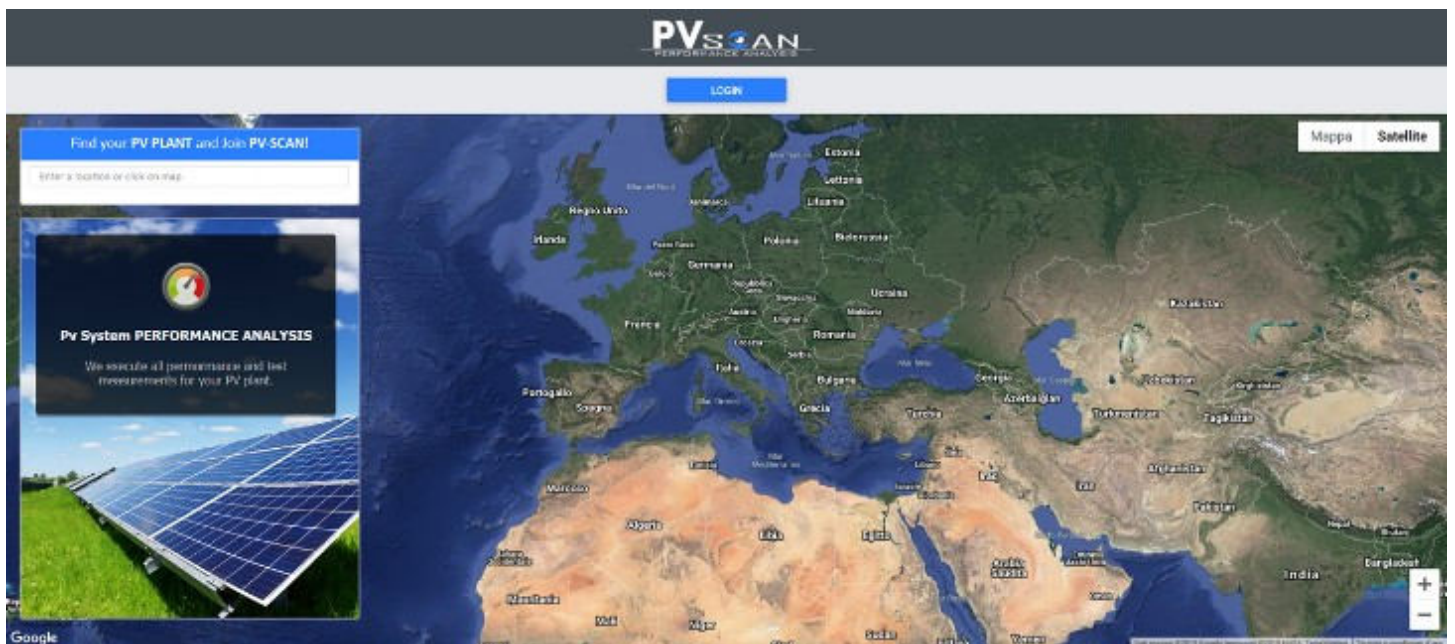
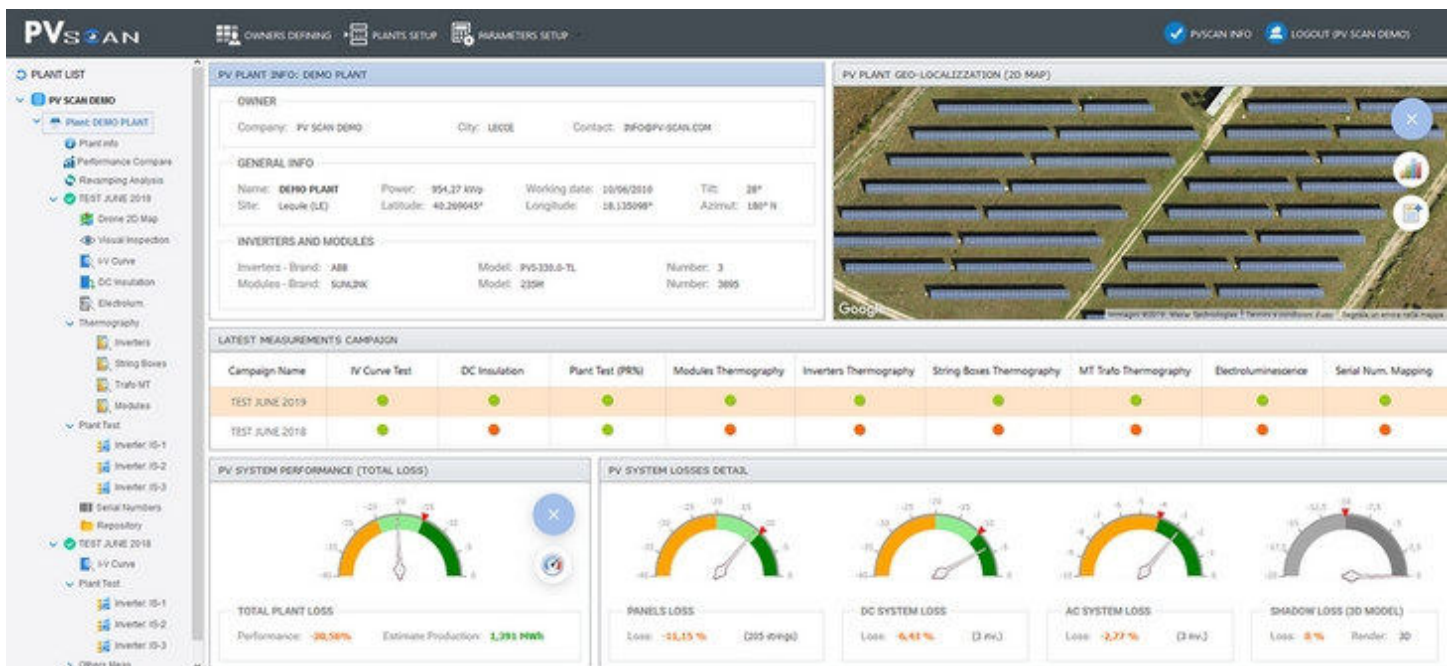
OUR "SMART" WEB PLATFORM PV-SCAN

PV-SCAN is the Smart platform for Photovoltaic Performance analysis, Reporting, Measurements data processing, Energy production prediction and Due Diligence web cloud, for O&M Company and Owners. Use PV-SCAN for monitoring performance trend of your PV plant park. [Join PV-SCAN on www.pv-scan.com/](http://www.pv-scan.com/)

PV PLANT INFO: DEMO PLANT

GENERAL INFO
 Name: DEMO PLANT Power: 954,37 kW Working date: 10/06/2019 Tilt: 28°
 Site: Leuce (LE) Latitude: 40.269045° Longitude: 18.135098° Azimut: 180° N

INVERTERS AND MODULES
 Inverters - Brand: ABB Model: PV5330-S-TL Number: 3
 Modules - Brand: SOLARIX Model: 2598 Number: 3695

- PANELS LOSS: Loss: **-11,15 %** (295 string)
- DC SYSTEM LOSS: Loss: **-6,41 %** (3 mV)
- AC SYSTEM LOSS: Loss: **-2,77 %** (3 mV)
- SHADOW LOSS (3D MODEL): Loss: **0 %** (Render: 30)

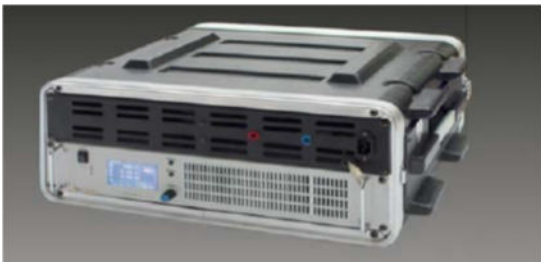
PV-SERVE

DC power supply for performing analyzes on photovoltaic modules such as Nighttime Electroluminescence Analysis, IV Curves in the Dark (DIV) and Night / Day IR Thermography

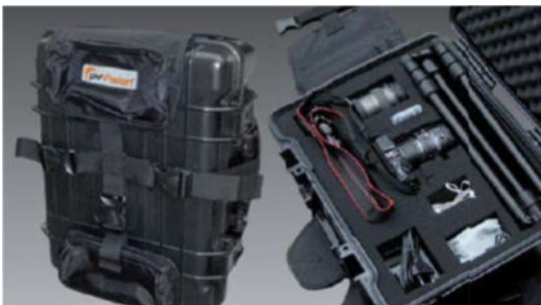
PV-VISION

IR camera for capturing photographs with the electroluminescence technique, directly in the field

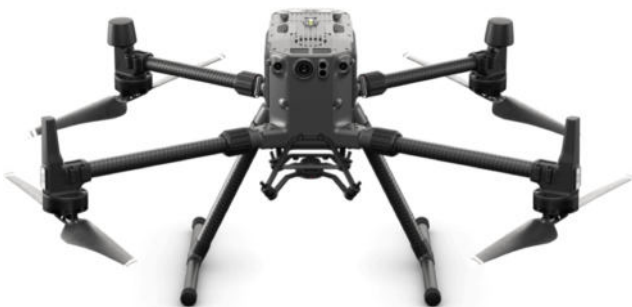
DJI MATRICE 300 RTK

DJI Matrice 300 RTK is the new industrial drone from DJI that draws inspiration directly from modern aeronautical systems, for inspections of photovoltaic systems, wind farms and high voltage overhead power lines

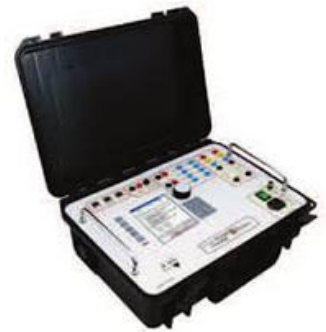
CHAUVIN ARNOUX FTV400

Relay tester for SPI and PG photovoltaic certification an testing

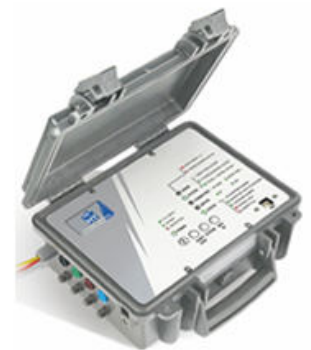
HT PQA 820

Three-Phase Energy Logger & Power Quality Analyzer for electrical systems
